Couple Executes Elevation Project in Combating Flood

Full Mitigation Best Practice Story

Henderson County, Illinois

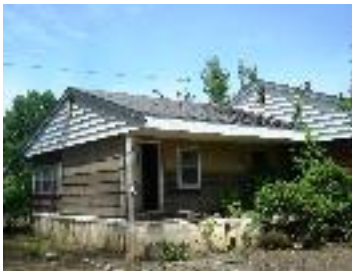
Damage to home located adjacent to the Opels' home

Alluding to the 2008 flood event, which warranted a Federal disaster declaration, Opel reported having approximately seven feet of water on his property. When the levee was breached, the water was about 18 inches from the bottom of the floor level. His next-door neighbor had four feet of water in her house. The river crested at 25.73 feet.
